June 12, 2024

Dana by the Sea HOA
24412 Alta Vista Drive
Dana Point, CA 92629
Attention: **Mike Hart**

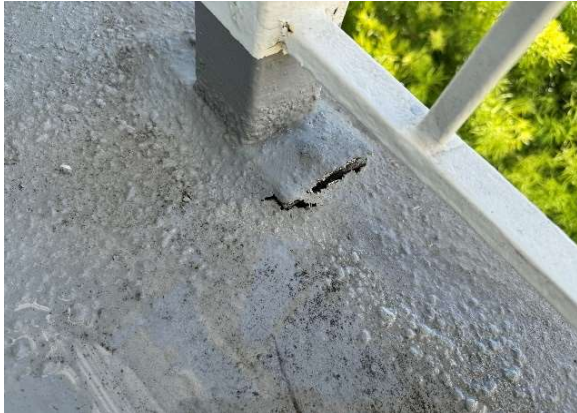
Figure 1: Typical decking with damage at guardrail post.

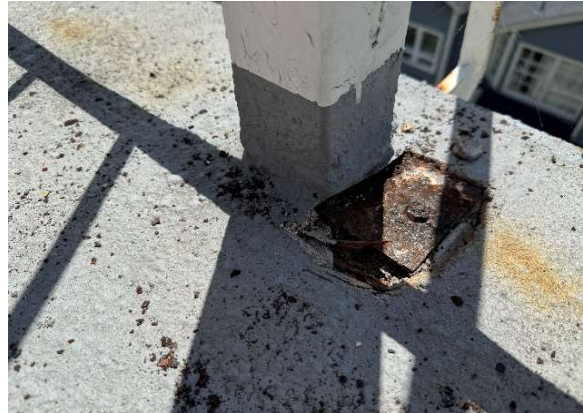
Figure 2: Severely rusted baseplate and rotten plywood photographed during intrusive inspection.

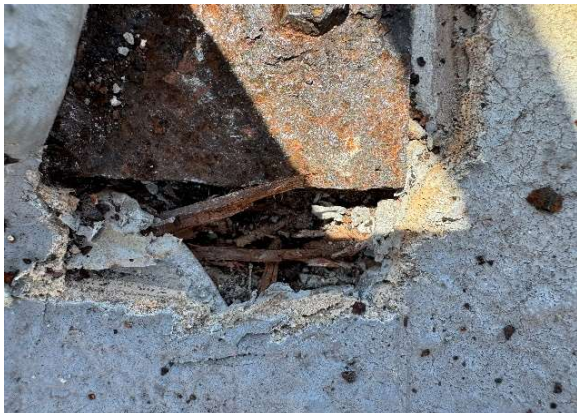
Figure 3: Severely rusted baseplate and rotten plywood photographed during intrusive inspection.

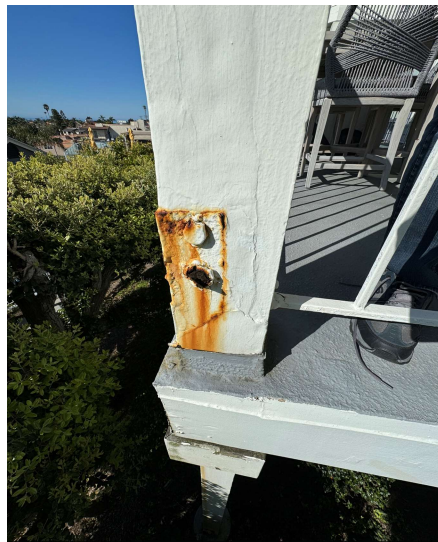
Figure 4: Severely rusted post-to-post strap.

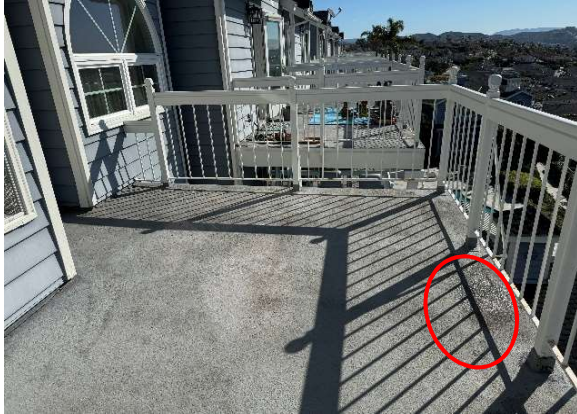
Figure 5: Upper deck where water is ponding.

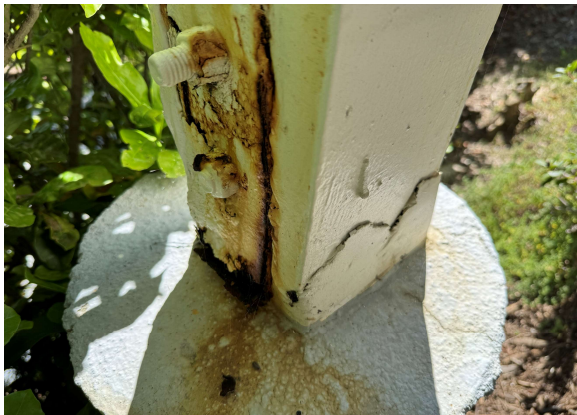
Figure 7: Typical post base with severe rust.

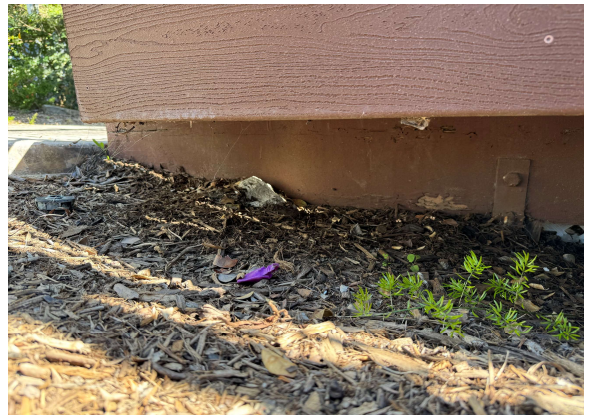
Figure 8: Wood in contact with soil.

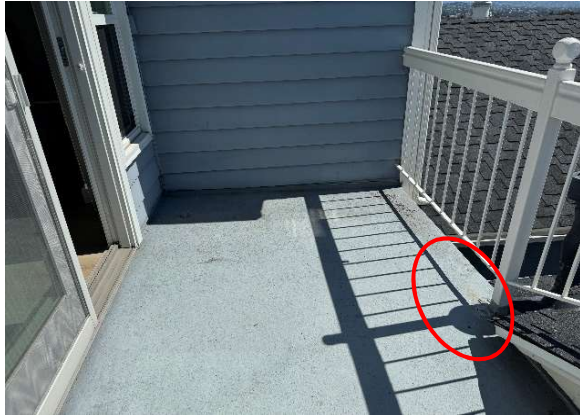
Figure 9: Granada upper (Master) balconies at typical area of water damage at guardrail post. Note this is a low point in the deck and a point of drainage.

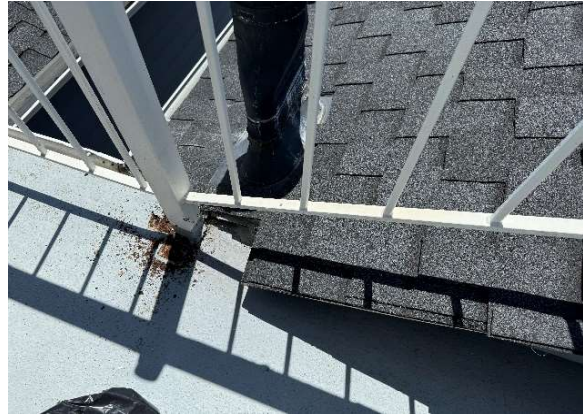
Figure 10: Baseplate exposed to show severe rust damage and damage to structure below.

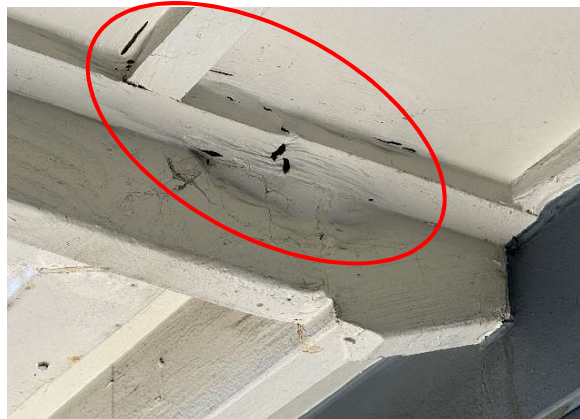
Figure 11: Visible water damage to wood elements directly below baseplate and leak noted in Figures 9 and 10.

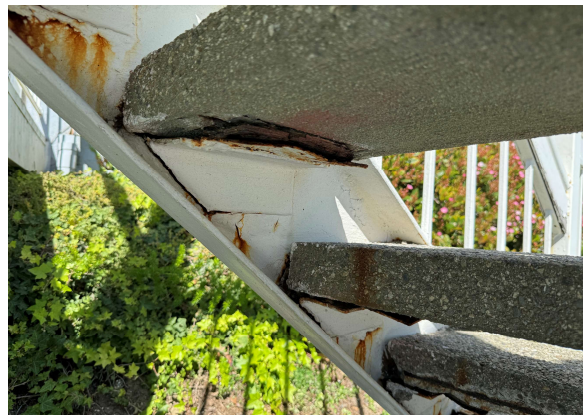
Figure 12: Severely rusted stair tread ledger angles.
