April 17, 2024

Subject: Dana by the Sea
SB 326 Intrusive Investigation Instructions

Dana by the Sea - SB 326 Inspections - Units

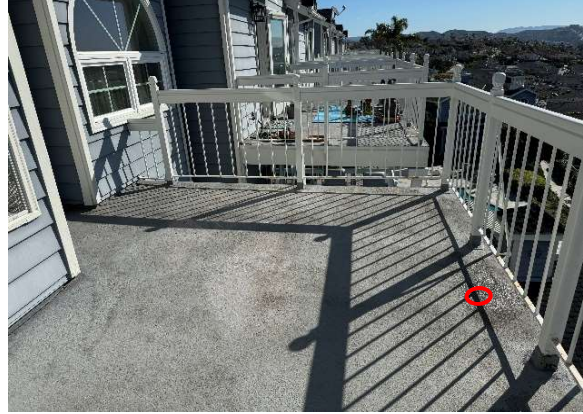
Unit	Stair	Low Deck	High Deck	Deck Posts	Intrusive required?	Instructions for areas required to opened up for inspection :
24414	N/A	Moderate gaurdrail rust.	Moderate gaurdrail rust. Gaurdrail post brace rusted significantly.	Both wood posts steel bases severely rusted. West second floor post strap severely rusted.	No	
24416	N/A	Cracking of waterproof layer near gaurdrail post base. Moderate gaurdrail rust.	Cracking of waterproof layer in two places. Gaurdrail is weak-- appears gaurdrail post is rusted off at base.	Two front wood posts steel bases severely rusted. Rear wood post is in direct contact with soil.	Yes	Expose gaurdrail post base (reference Figure E1).
24422	N/A	Deck post at SE corner is rotted/ termite damaged severely and requires replacment.	Moderate guardrail rust.	Both wood posts steel bases severely rusted.	No	
24424	N/A	No issues discovered.	Plywood sagging near edge. Water ponding. Significant rust at gaurdrail.	Front West post steel base severely rusted. Front East post is degraded and steel base severely rusted. Rear post steel base severely rusted.	Yes	Bore hole in soffit below upper level deck below sagging plywood (reference Figure E2).

Figure E2 (24424): Drill 1" hole through wood soffit finish BELOW this area of the upper deck where water is ponding. Inspection will be provided via endoscope.

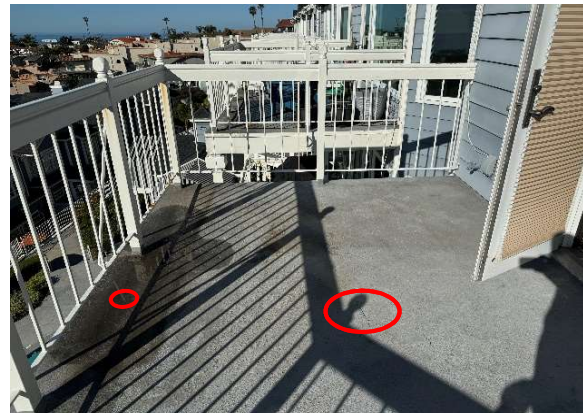
24426	N/A	Deck has covering in place. Significnat guardrail rust.	Significant guardrail rust.	Both wood posts steel bases marginally rusted.	No	
24432	N/A	No issues discovered.	Cracking of waterproof layer.	Two front wood posts steel bases severely rusted. Rear wood post bases martinally rusted.	Yes	Expose top of plywood at crack in waterproof layer (reference Figure E3).
24434	N/A	No issues discovered.	No issues discovered.	West wood posts steel base severely rusted. West second floor post strap severely rusted.	No	
24436	N/A	Deck has been covered by heavy tile and may be beyond weight structure is designed for. Significant guardrail rust.	Significant cracking and damage to waterproof layer. Standing water at rail.	Front West post steel base marginally rusted. Front East and Rear post is steel base severely rusted. Rear post steel base severely rusted.	Yes	Bore holes in soffit below upper level deck below cracking in waterproof layer and below ponding (reference Figure E4).

Figure E4 (24436): Drill 1" hole through wood soffit finish BELOW two noted areas in the upper deck where: water is ponding and at large crack in waterproofing. Inspection will be provided via endoscope.

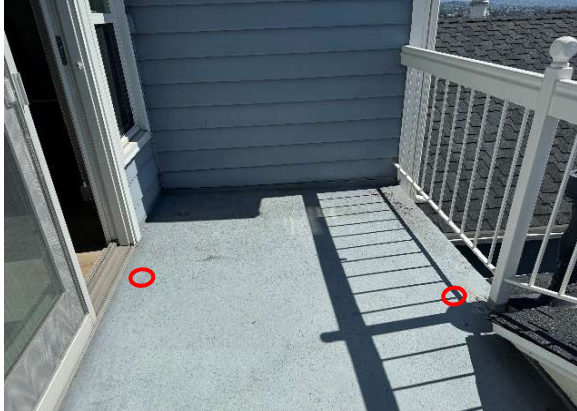
Unit	Stair	Low Deck	High Deck	Deck Posts	Intrusive required?	Instructions for areas required to opened up for inspection :
24448	N/A	Ocean side: Deck has been covered by heavy tile and may be beyond weight structure is designed for. No other issues discovered. Pool side: Open Trex deck. All 3 main wood beams are rotted. One beam needs to be raised above grade. Wood posts need to be raised above grade.	Deck has been covered by heavy tile and may be beyond weight structure is designed for. No other issues discovered.		No	
33651	No issues discovered.	Rail to front door rusted severely.	Rail post is rusted at base.	4x4 post supporting deck rotted significantly at the base.	No	
33655	No issues discovered.	Significant gaurdrail post rust at base.	Rail post is rusted off at base.	N/A	Yes	
33661	No issues discovered.	No issues discovered.	No issues discovered.	N/A	No	
33665	No issues discovered.	No issues discovered.	Rail post is rusted off at base.	N/A	Yes	Bore hole in soffit below post location and ledger location at upper level deck (reference Figure E5).

Figure E5 (33665): Drill 1" hole through finish BELOW ledger location and post location at upper deck. Inspection will be provided via endoscope.

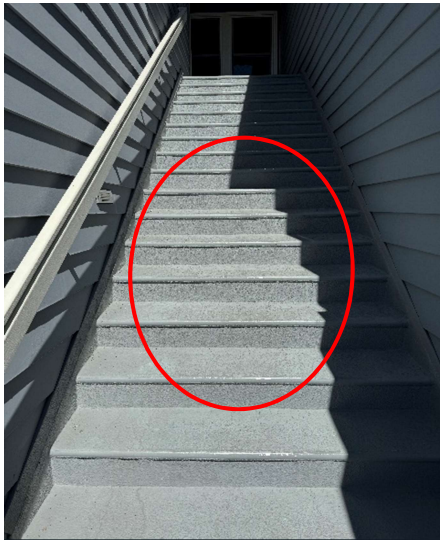
33671	No issues discovered.	No issues discovered.	No issues discovered.	N/A	No	
33675	No issues discovered.	No issues discovered.	Rail post is likely rusted off at base.	N/A	Yes	
33681	No issues discovered.	No issues discovered.	Rail post is rusted off at base.	N/A	No	
33685	Waterproof layer is cracked.	Waterproof layer has small cracks.	Rail post is rusted off at base.	N/A	Yes	Bore hole in finish below upper level deck crack in waterproof layer (reference Figure E6). Expose underside of stair framing for visual inspection (reference Figure E7).
33691	No issues discovered.	No issues discovered.	Rail post is rusted off at base.	N/A	No

Figure E7 (33685): Remove drywall (minimum 2' x 2' section) to expose underside of stairs.
