CALIFORNIA BUILDER SERVICES

RESERVE ANALYSIS REPORT

Dana by The Sea
Steet of the Blue Lantern & Alta Vista Dr.
Dana Point, CA 92629

Full Study | FY25/26

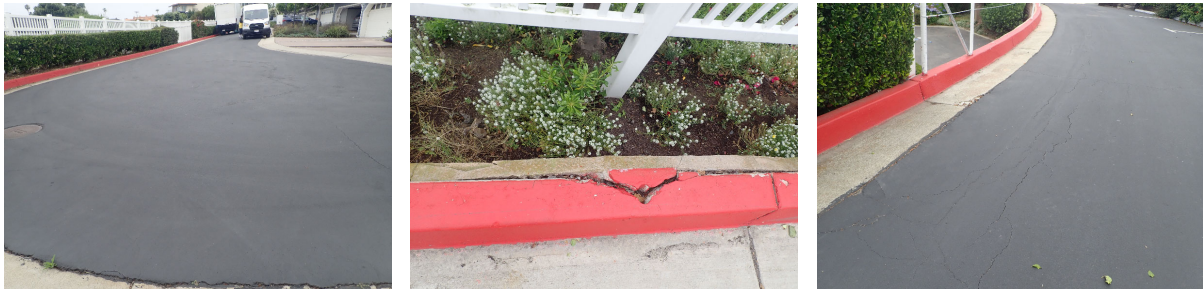
Paving - Asphalt; Overlay & Replacement - 2038

This component is to apply a petromat overlay on top of the existing asphalt surface along with 1-1/2" of new hot mix. Generally, this includes edge grinding, utility box extensions, and filling potholes. The observed condition of Granada Dr road was good. Damage to asphalt is typically a result of several different factors, including time, weather conditions, improper maintenance, and chemical exposure from gasoline, cleaning solutions, oil, etc.

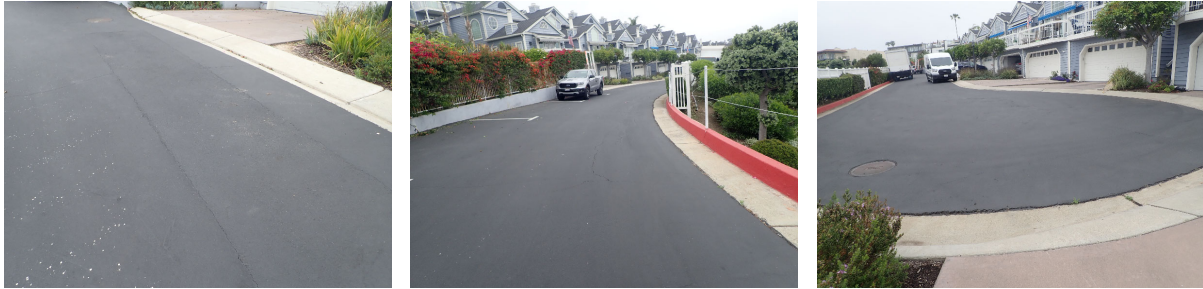
Paving - Asphalt; Slurry Seal & Repairs continued...

This component is for the preparation of the asphalt and application of the slurry seal coat. A seal coat is a thin liquid application that provides a sealant that helps prevent damage from the elements. This component includes striping, crack fill, skin patching, minor dig out & fill, etc. If a second coat is desired the cost is generally 10% to 20% higher. Cracks 1/4" or wider should be filled when observed. The observed condition of Granada Dr road was good.

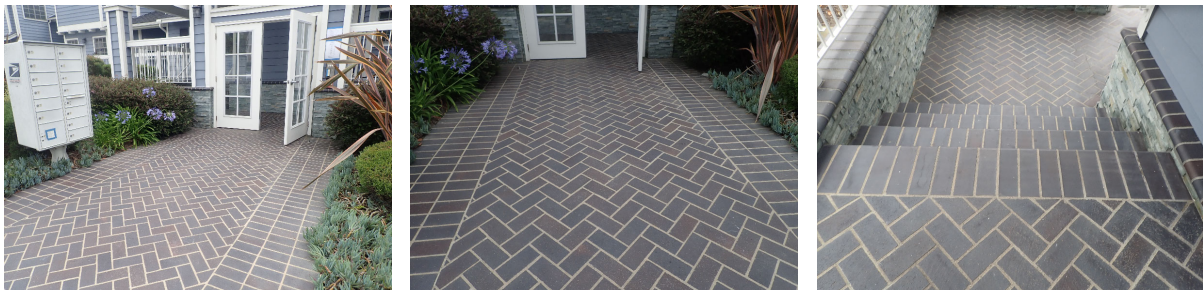
Paving - Brick Pavers; Maintenance & Repairs - 2034

This component is for the periodic maintenance and repair of the concrete pavers, located at the front entrance facing Alta Vista Dr. Overall, the pavers appeared in good condition with no problems observed. Periodic maintenance may include mechanical and/or chemical cleaning, efflorescence removal, sealing, grinding, minor repair or replacement. If properly maintained,

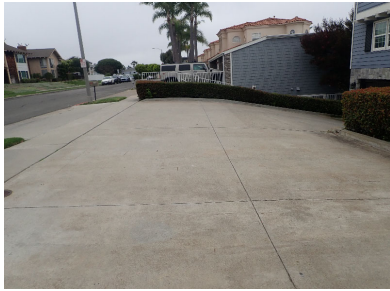
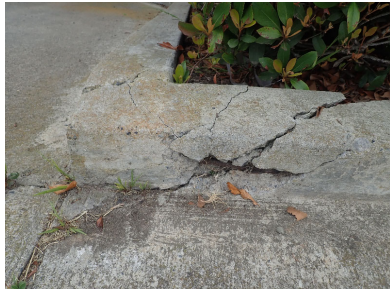
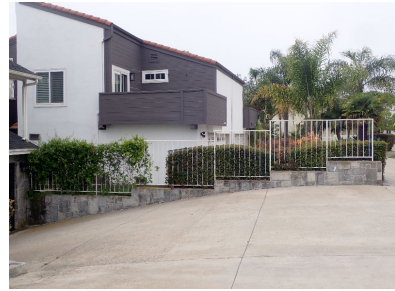
Paving - Concrete Drive; Maintenance & Repairs - 2034

This component covers the periodic maintenance & repairs of the concrete pavement located at the entrances to the garage facing Alta Vista Dr. Annual inspections are necessary to ensure correction of any elevation changes and trip hazards the association may be held liable for. When cracks occur, and are not repaired in a timely fashion, moisture can infiltrate and further degrade the materials. The concretes' overall appearance is in good to fair condition with a few hairline cracks and one large developing crack on the raised driveway edging.

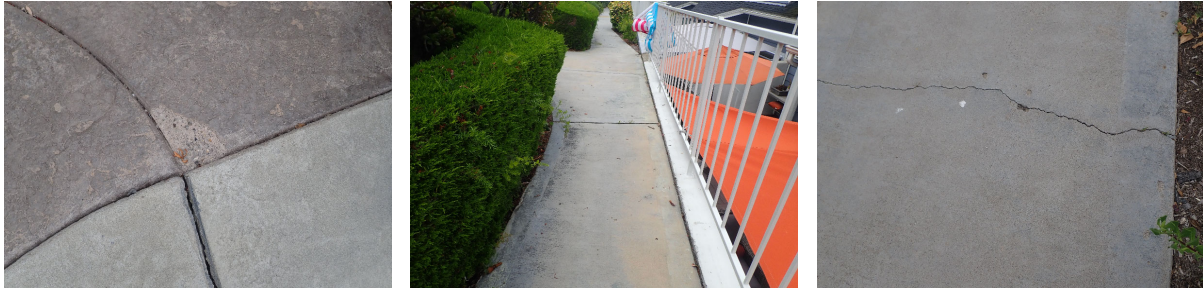
Paving - Concrete Walks; Maintenance & Repairs continued...

This component covers the periodic maintenance & repairs of the concrete walkways located throughout the common areas of the development. Annual inspections are necessary to ensure correction of any elevation changes and trip hazards the association may be held liable for. When cracks occur, and are not repaired in a timely fashion, moisture can infiltrate and further degrade the materials. The concrete is in overall fair condition with few hairline cracks but no noticeable large fractures or lifting.

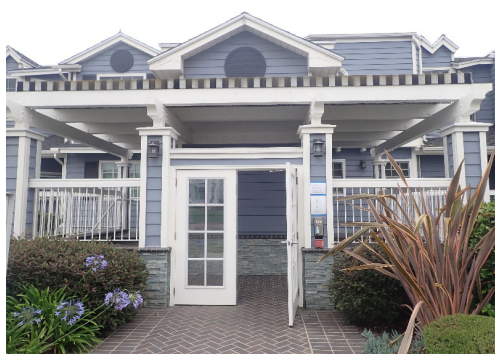
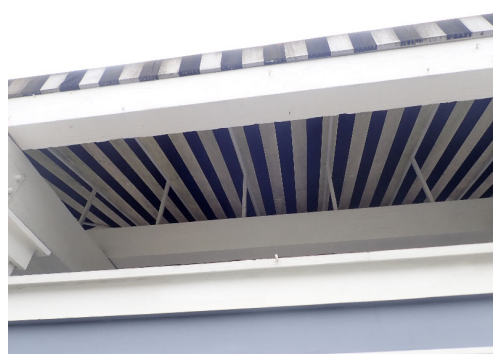
Roof - Alta Vista Canopy; Replacement - 2027

This component covers replacement of the entryway canopy. At the time of inspection, it appeared to be in fair condition.

*Per HOA, replacement date projected for 2027.

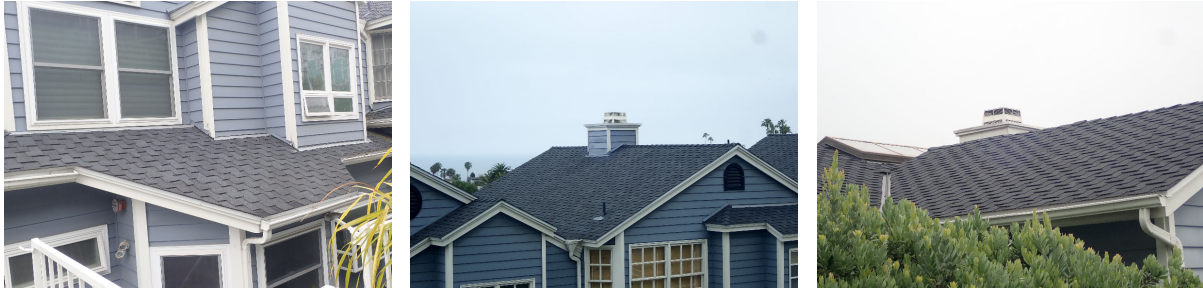
Roof - Comp. Shingle; Replacement continued...

Shingled roofs are typically composed of asphalt shingles, which consist of a fiberglass or organic mat base coated with asphalt and embedded with mineral granules for added durability. This composition provides resistance to weather, UV rays, and general wear over time. While shingled roofs offer a cost-effective and widely used roofing solution, they require regular maintenance and have a lifespan that varies depending on climate conditions and material quality. At the time of inspection, the condition of the roofs appeared to be good.

*It is recommended that all roofs over 10 years old be inspected by a reputable roofing contractor and be repaired as indicated.

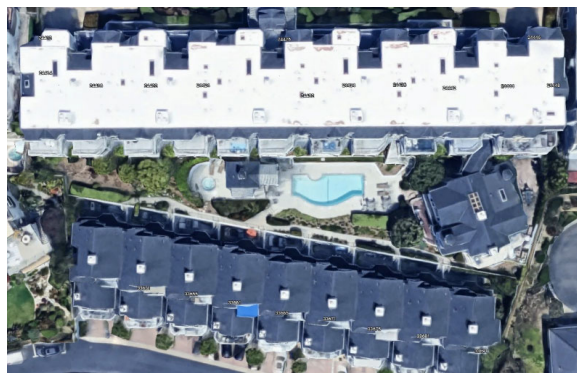
Roof - Flat Single-Ply; Replacement - 2040

Cool roofs are designed to reflect sunlight and absorb less heat than a standard composition

shingle or tile roofing system, allowing for significant energy savings from decreased air conditioning. Single-ply membranes are pre-fabricated sheets rolled onto the roof and attached with mechanical fasteners or adhesives. The most important maintenance is to ensure proper draining. If ponding occurs, eventually this will seep through and cause costly damage to the surface underneath. Often this damage isn't detected until rot and mold are present. Checking the seams, flashings and all around the rooftop penetrations, periodically and after rain storms should be done.

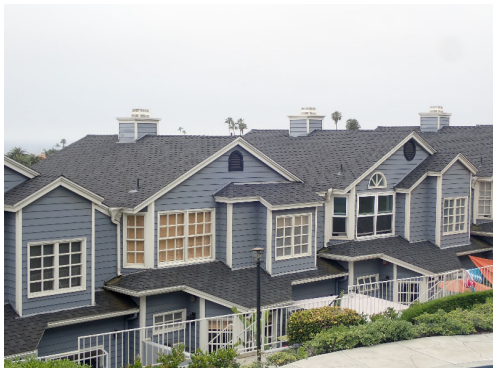
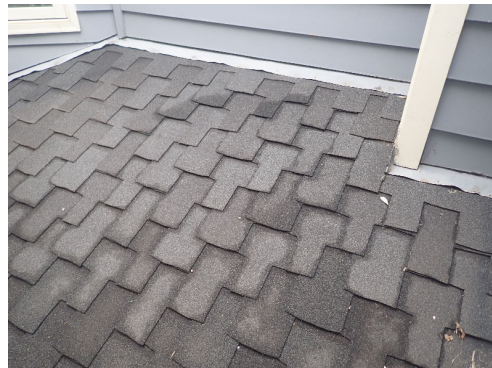
This component provides for periodic roof inspections as part of a proactive maintenance strategy. Regular roof inspections are essential in identifying early signs of deterioration, leaks, or structural issues before they lead to costly repairs or premature replacement. Benefits of routine inspections include extending the roof's useful life, minimizing emergency repair costs, maintaining warranty compliance, and ensuring the overall integrity of the building envelope. While inspections do require a modest investment and may uncover the need for additional repairs, the long-term cost savings and risk mitigation far outweigh the short-term expense. Given the critical role the roof plays in protecting the structure, these inspections are strongly recommended at regular intervals, particularly following severe weather events or as the roof nears mid-life.

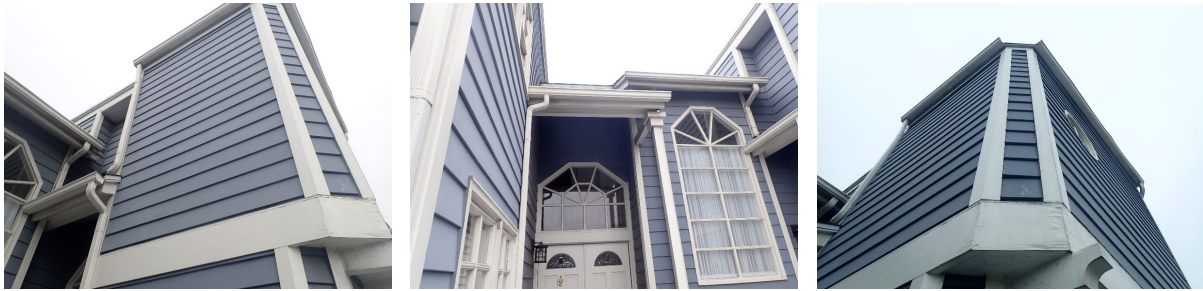
The present condition of the exterior paint on the plank siding & trim is fair. There are no areas where the paint is starting to peel and chip away. Proper painting intervals will help protect the component underneath from unnecessary damage from exposure to the elements. Before the buildings are painted, preparation should include power washing, scraping, sanding, and repairs as found necessary.

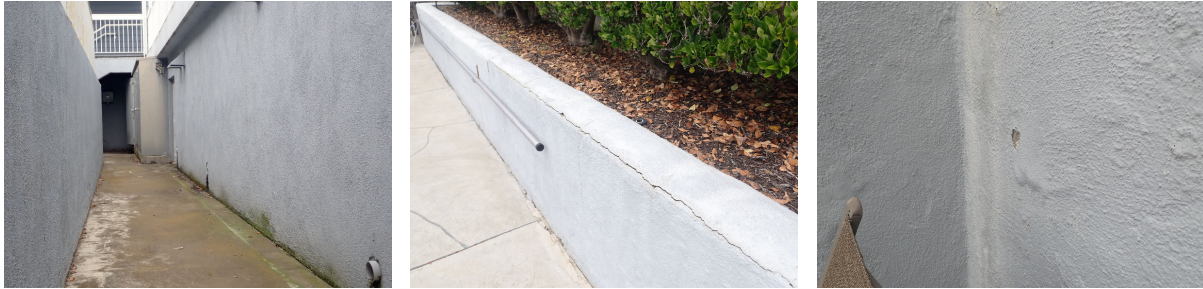
This component is for the painting of the stucco located throughout the exteriors of the building. It is recommended that all stucco surfaces be painted on a seven (7) year cycle in order to prevent the premature wear and maintain aesthetic appeal. At the time of inspection, the paint was noted to be in fair condition with some signs of noticeable wear, such as chipping, cracking, and discoloration.

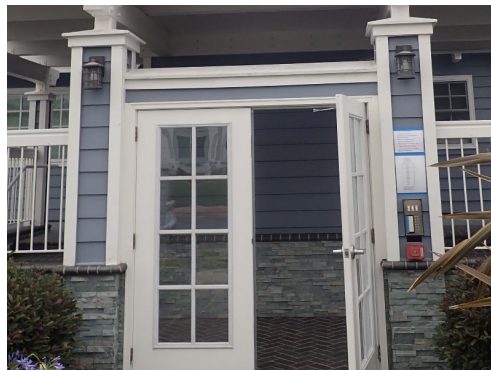
The present condition of the paint on the wood doors is good. There was no evidence of paint starting to peel and/or chip away. Proper painting intervals will help protect the component underneath from unnecessary damage from exposure to the elements. Before the components are painted, preparation should include power washing, scraping, sanding, and repairs as found necessary.

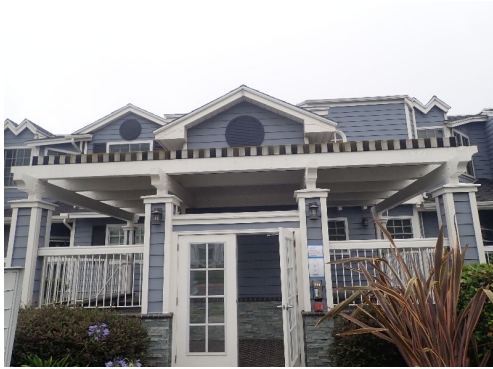
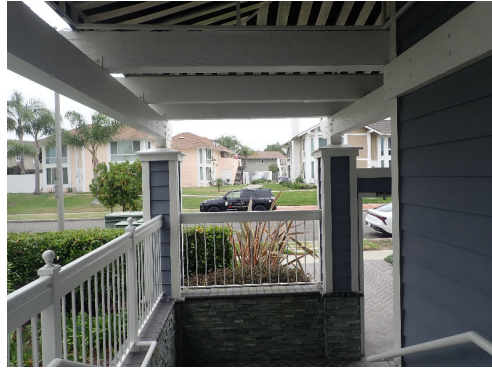
Building - Entry Pergola; Repairs & Replacement - 2039

This component is for the repairs and partial replacement of the entry pergola facing Alta Vista Dr. At the time of inspection, the component appeared to be in good condition, showing no sign of damage or defect.

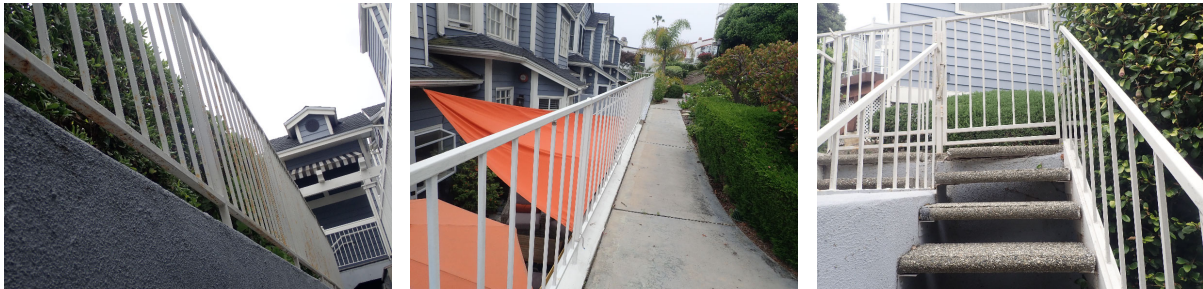
This component is for the replacement of the pedestrian gates and fencing in the development. At the time of inspection, the overall condition of gates & fencing was fair. Normal weathering, surface rust and paint deterioration was observed but none rampant enough to cause major structural damage or defect. Painting is provided with another component.

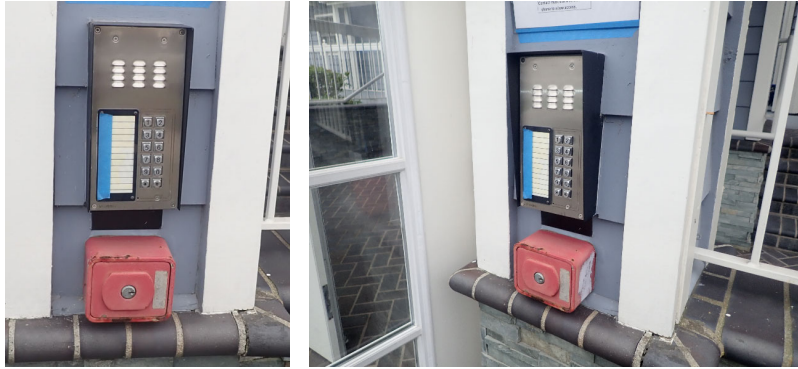
The Viking entry phone system appeared to be in good condition without any sign of damage or malfunction. Typically, if the keys show signs of wear or sticking, the key code can be changed to less frequently used numbers to extend the life of the component and provide more equal wear.

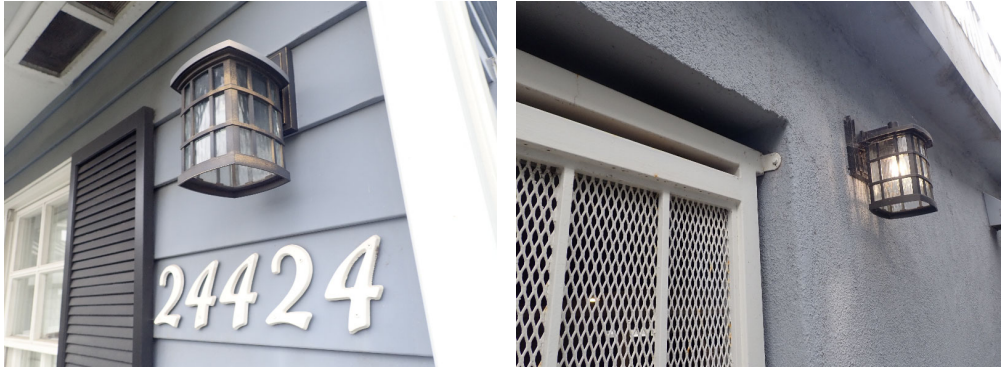
This component is for the replacement of the exterior wall-mounted light fixtures. They appeared to be in good condition at the time of inspection with minimal signs of cosmetic wear. Bulbs are an operating expense and should be replaced as noted.

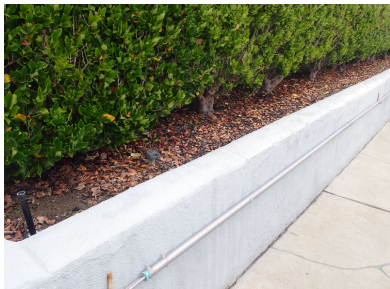
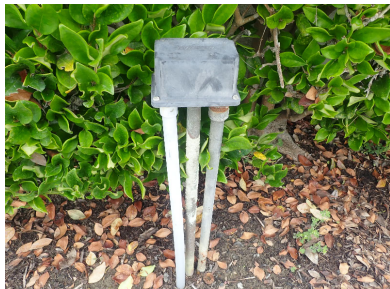
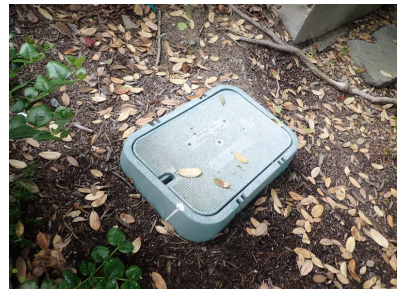
This component is for the periodic partial replacement of the irrigation system, which appeared to be in fair condition at the time of inspection. There were no major signs of operational problems such as the pooling of water, ground over saturation, or broken equipment.

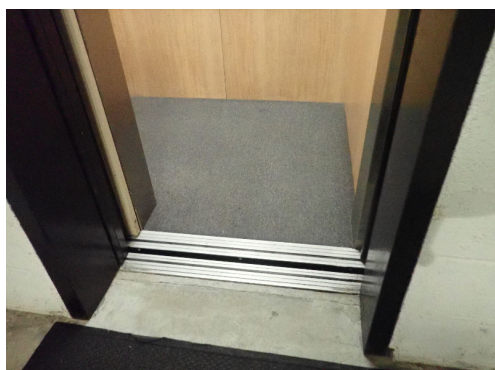
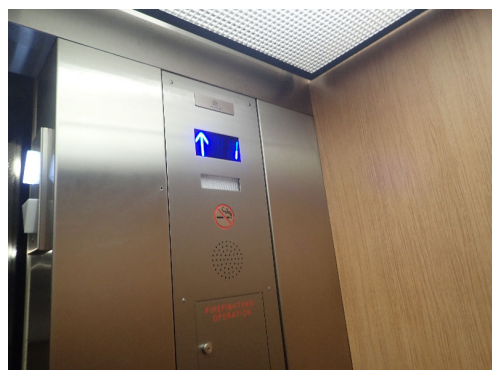
This component is to replace the interior furnishings of the elevator cab. This includes, sidings, lights, carpet, tile, buttons, etc. The useful life of this item is highly correlated with the amount of use. At the time of inspection the condition was good.

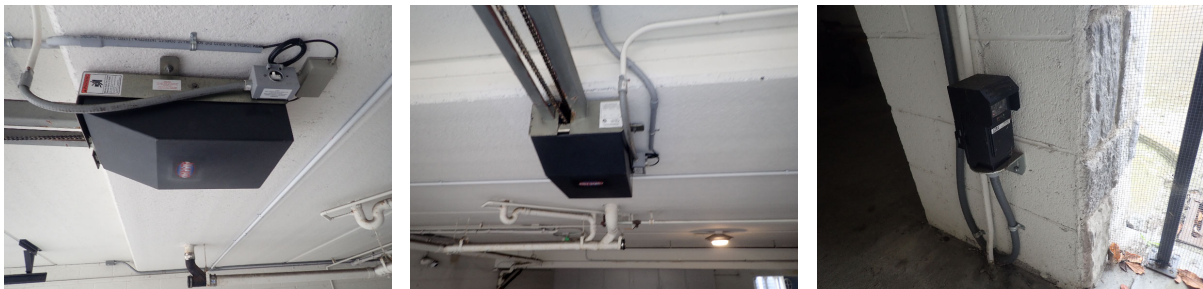
This component is for the replacement of the overhead All-O-Matic garage door openers. At the time of inspection, the garage door openers appeared to be in fair condition. Regular

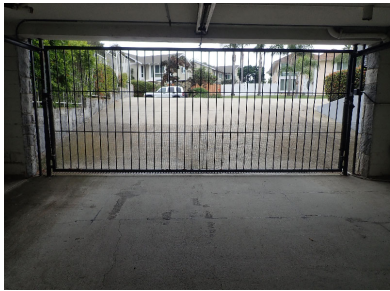
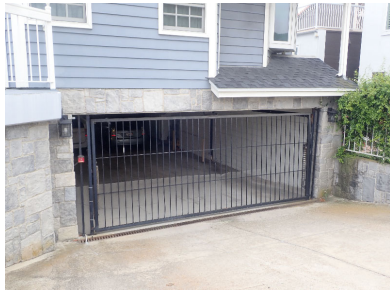
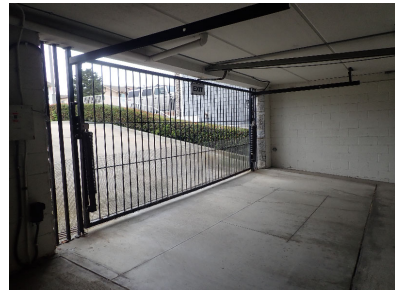
This component is for the replacement of the wrought iron parking garage gates. At the time of inspection, it appeared to be in fair condition with some signs of rust but no major damage or defect noted impeding its function. Painting is provided for in another component.

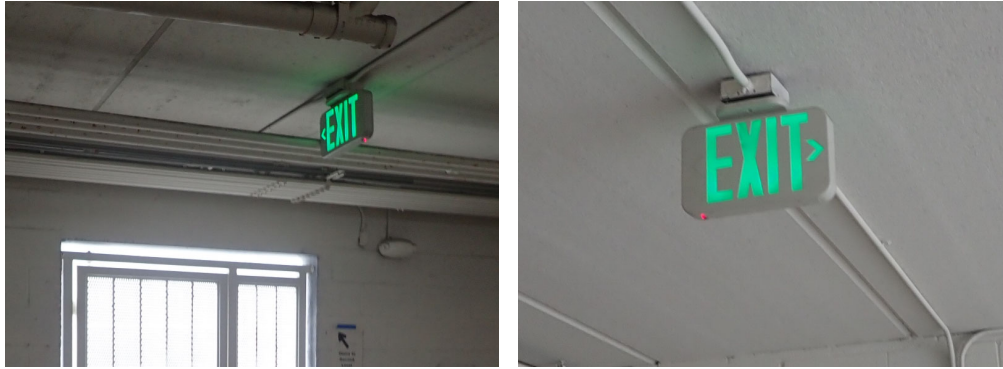
This component covers the replacement of the illuminated exit signs located in the parking garage; although rare, these fixtures will have to be replaced periodically due to age, stress on fittings, fraying of wires, corrosion, or many other factors. At the time of inspection, the lights appeared to be functioning properly without signs of damage and in good condition.

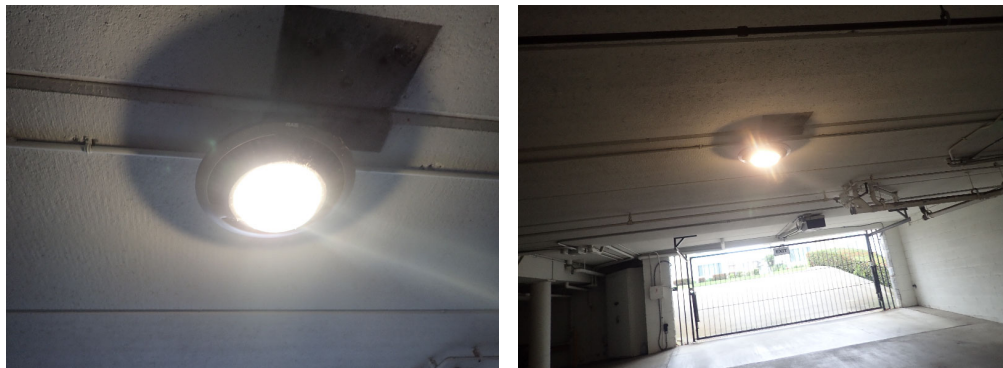
This component covers the replacement of the round light fixtures located in the parking garage; although rare, these fixtures will have to be replaced periodically due to age, stress on fittings, fraying of wires, corrosion, or many other factors. At the time of inspection, the lights appeared to be functioning properly without signs of damage and in good condition.

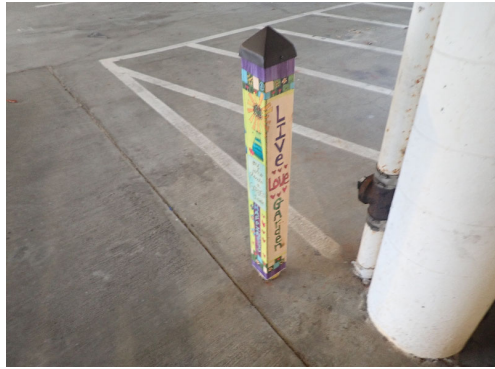
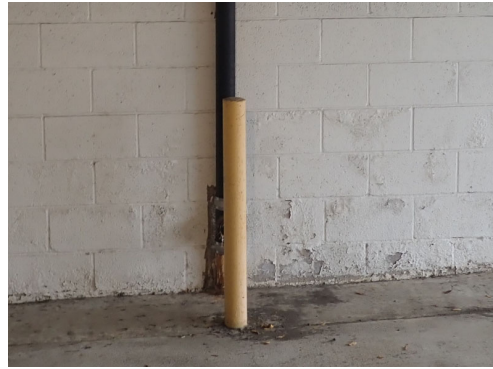
This component covers the painting of the bollards in the garage. At the time of inspection, the paint appeared to be in fair condition with minimal signs of cracking, peeling, chalking, or other aging damage. If a change in color, texture, type or paint scheme is desired, a primer base and/or additional coats of paint may be required, which will increase the cost of this component.

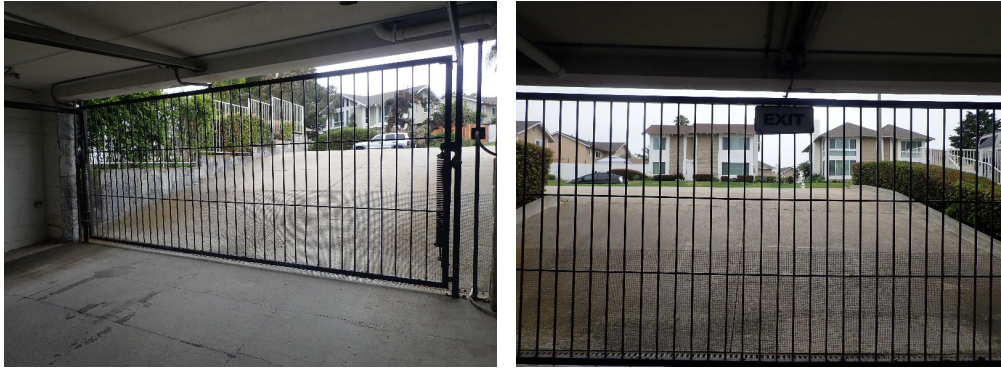
The condition of the paint on the vehicle gate is fair showing fading of its color. Proper painting intervals will help protect the component underneath from unnecessary damage from exposure to the elements. Before the doors are painted, preparation should include power washing, scraping, sanding, and repairs as found necessary.

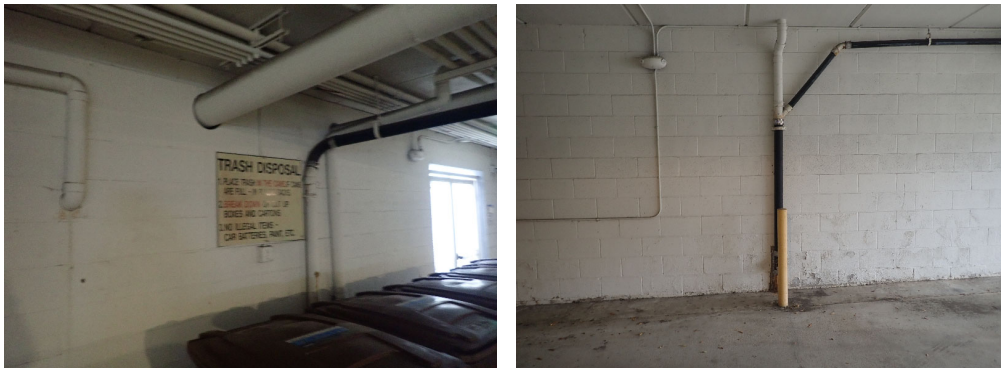
This component covers the repainting of the interior walls of the garage. At the time of inspection, the paint appeared to be in fair condition with minor signs of cracking, peeling, chalking, or other aging damage. If a change in color, texture, type or paint scheme is desired, a primer base and/or additional coats of paint may be required, which will increase the cost of

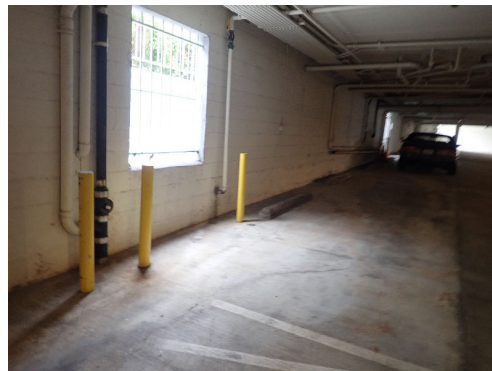
This component covers the replacement of the bollards in the garage. At the time of inspection, the bollards appeared to be in fair condition without structural damage or defect.

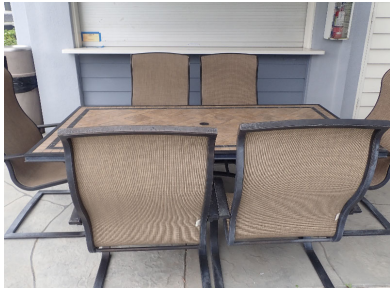
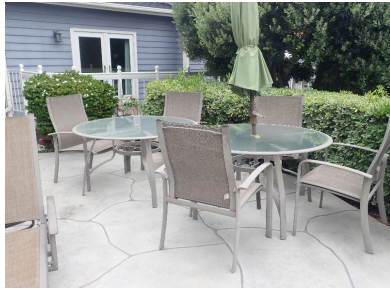
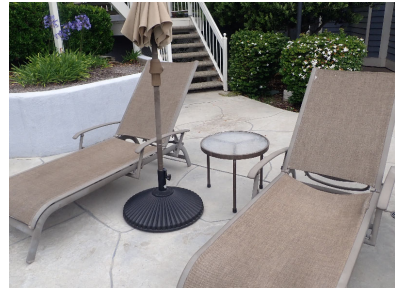
This component will replace the pool furnishings and lounging equipment. This component may vary greatly based on weather, quality, availability, amount of use, and potential vandalism. At the time of inspection the general condition of the assorted furnishings was fair.

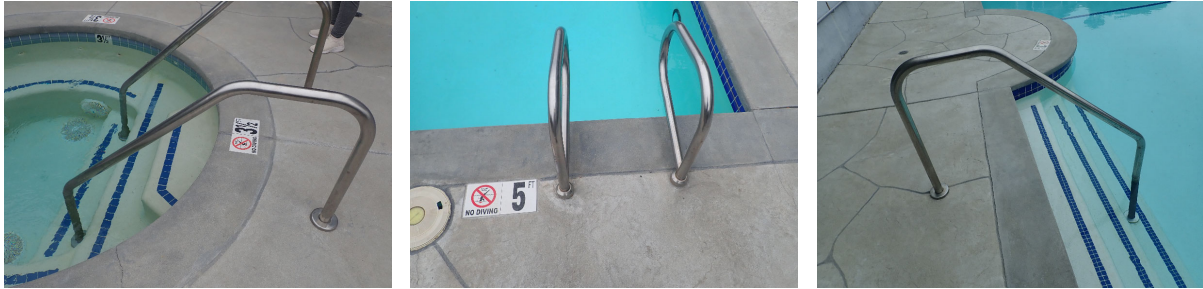
This component is for the hand rails going into the pool. At the time of inspection, all of the hand rails had minimal to no amount of movement from side to side. This unit cost takes into account the hand rails, other materials required, and labor to install.

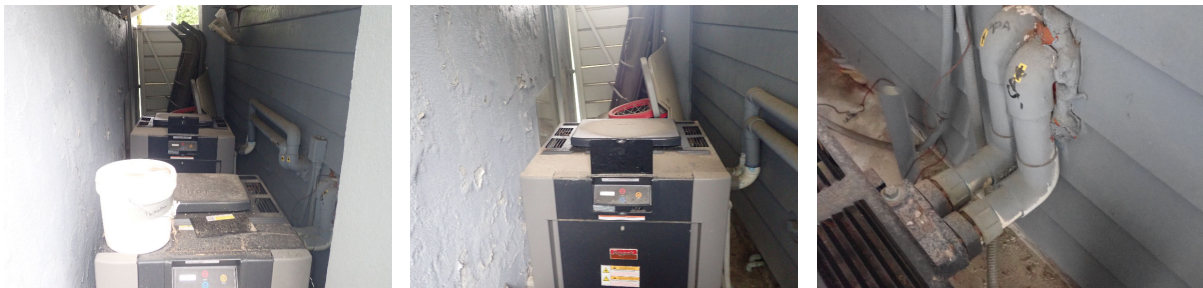
This component covers the periodic repair & replacement of the pool pumps, motors, sand filter, etc. The useful life varies based on use and quality of equipment. At the time of inspection, the equipment was noted to be functioning. Annual maintenance is recommended to prolong the components useful life.

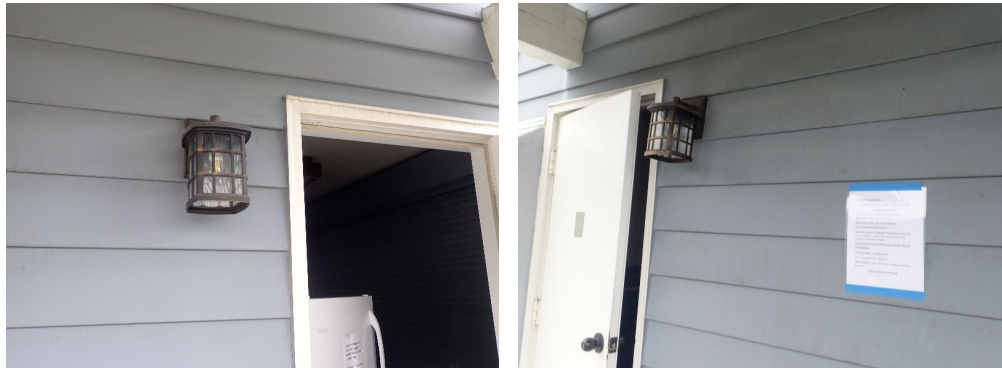
This component is for the replacement of the exterior wall-mounted light fixtures. They appeared to be in good condition at the time of inspection with minimal signs of cosmetic wear. Bulbs are an operating expense and should be replaced as noted.

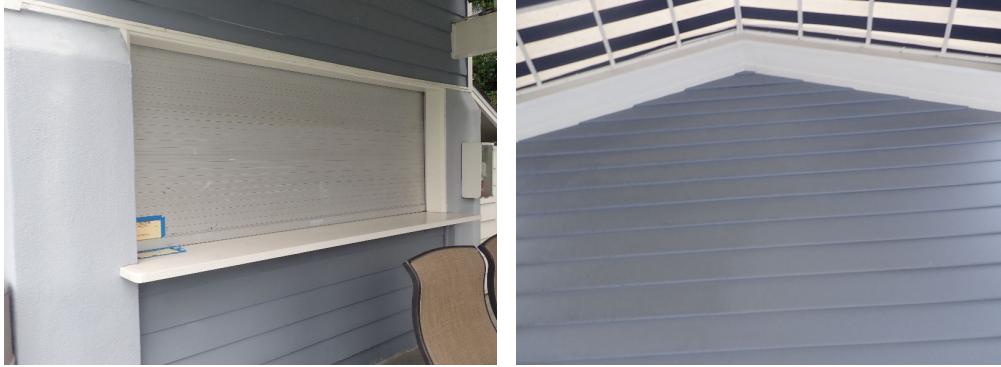
The present condition of the exterior paint on the plank siding & trim is fair. There are no areas where the paint is starting to peel and chip away. Proper painting intervals will help protect the component underneath from unnecessary damage from exposure to the elements. Before the building is painted, preparation should include power washing, scraping, sanding, and repairs as found necessary.

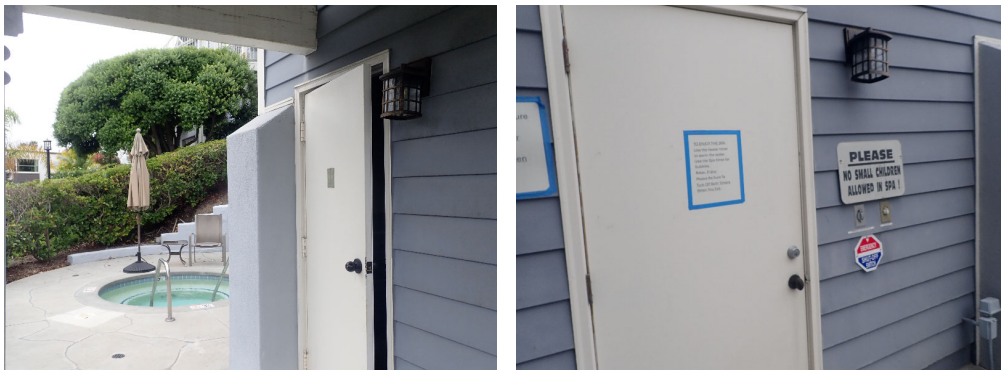
The present condition of the exterior paint on the door is fair. There are no areas where the paint is starting to peel and chip away. Proper painting intervals will help protect the component underneath from unnecessary damage from exposure to the elements. Before the doors are painted, preparation should include power washing, scraping, sanding, and repairs as found necessary.

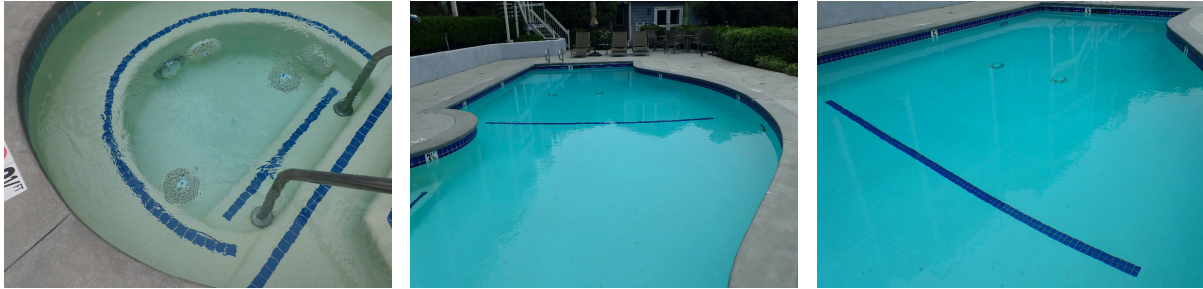
This component is for the re-surfacing of the swimming pool and spa. The re-surfacing consists of draining, cleaning, tile replacement (as applicable), plastering, and refilling. At the time of inspection, the surface of the pool and spa appeared to be in good condition.

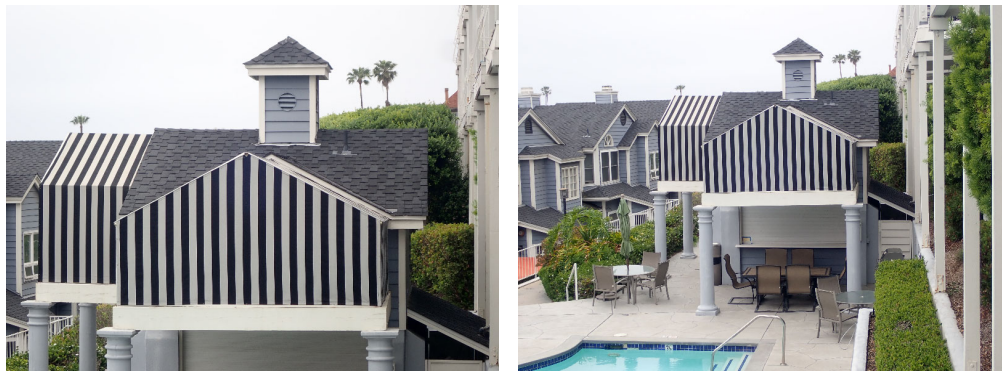
Shingled roofs are typically composed of asphalt shingles, which consist of a fiberglass or organic mat base coated with asphalt and embedded with mineral granules for added durability. This composition provides resistance to weather, UV rays, and general wear over time. While shingled roofs offer a cost-effective and widely used roofing solution, they require regular maintenance and have a lifespan that varies depending on climate conditions and material quality. At the time of inspection, the condition of the roof appeared to be good.

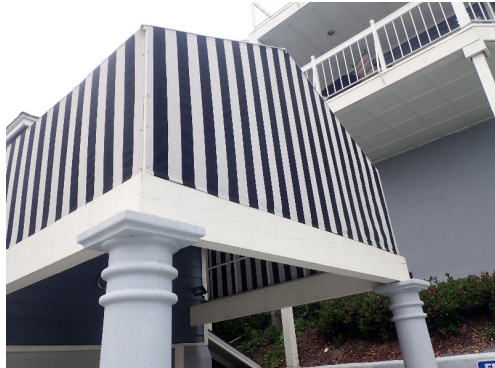
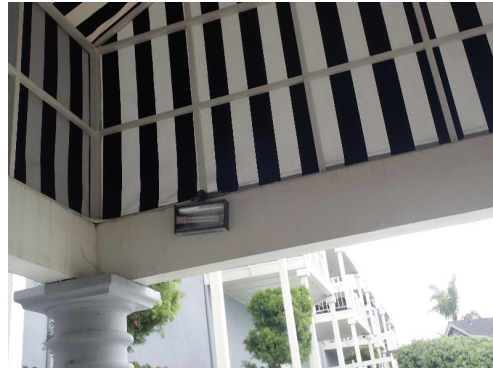
This component covers replacement of the canopy at the pool building. At the time of inspection, it appeared to be in fair condition.

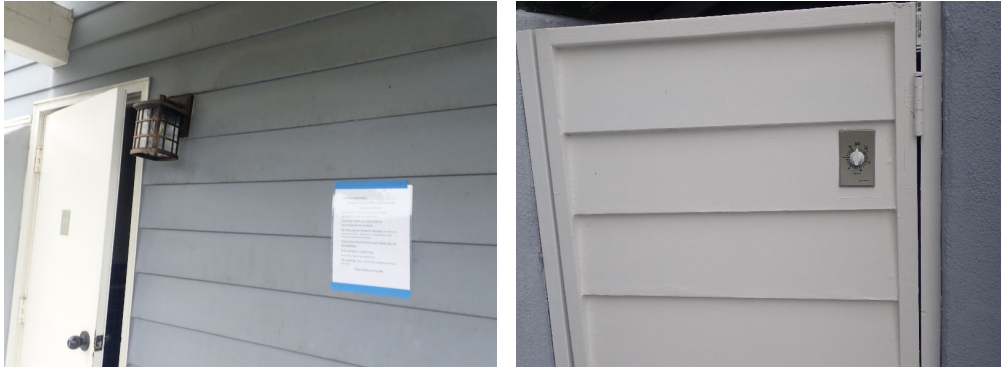
This component is for the replacement of the utility doors of the pool building. At the time of inspection, they showed no signs of damage or defect. Painting is provided for in another component.

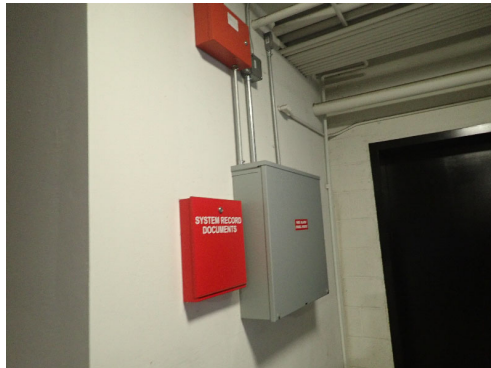
At the time of inspection the fire alarm system looks in good condition. This reserve funding is for any needed upgrades & repairs to this system.
