CALIFORNIA BUILDER SERVICES

RESERVE ANALYSIS REPORT

Dana by The Sea
Steet of the Blue Lantern & Alta Vista Dr.
Dana Point, CA 92629

Full Study | FY25/26

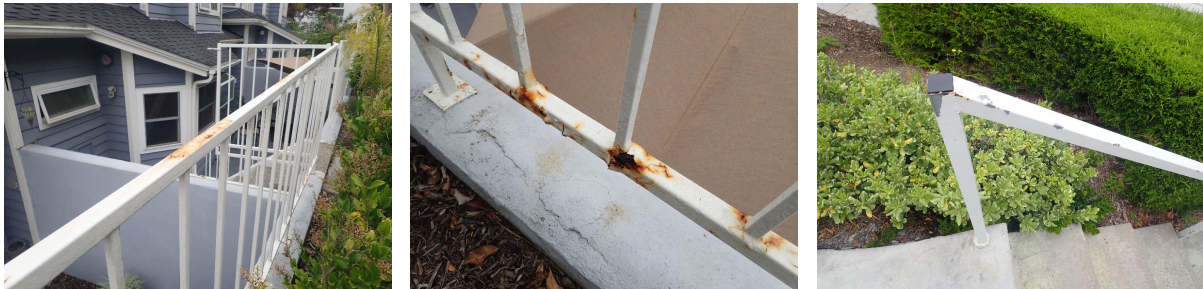
Painting - Gates, Fencing, & Railings; Metal & Wood - 2025

This component is to prepare, power wash, sand, scrape, spot prime and paint the wrought iron and wood balcony railings, hand/stair railings, gates and fencing. To ensure the wrought iron and wood achieves its full useful life, it should be painted as recommended. The paint at the time of inspection varied from fair to poor depending on the area. Without proper paint maintenance, the useful life of wrought iron can be greatly diminished.

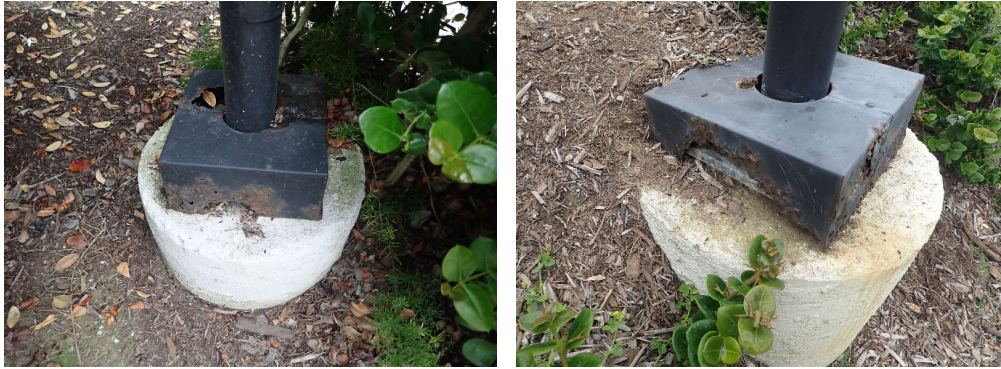
Painting - Post Light Fixtures; Metal continued...

This component is to prepare, power wash, sand, scrape, spot prime and paint the metal post lights throughout the common area of the community. To ensure the metal post achieves its full useful life, it should be painted as recommended. The paint at the time of inspection varied from fair to poor depending on one light post and mainly at the base of the post. Without proper paint maintenance, the useful life of light post can be greatly diminished.

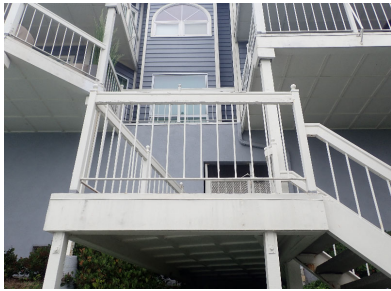
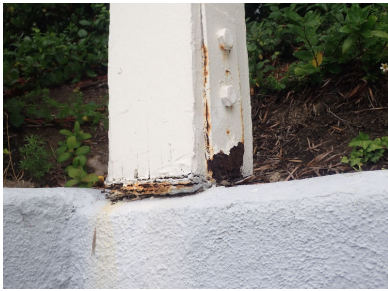
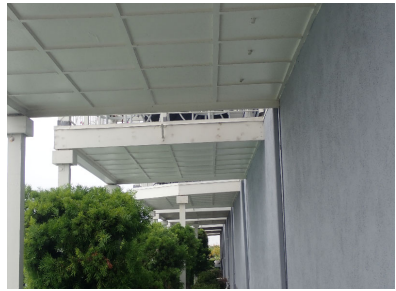
Building - Deck; Maintenance & Repairs - 2027

This component is for the maintenance and repairs of the decks. This is not for full teardown & full replacement. Plan on repairs, resurfacing and partial replacement of boards due to normal deterioration and wear.

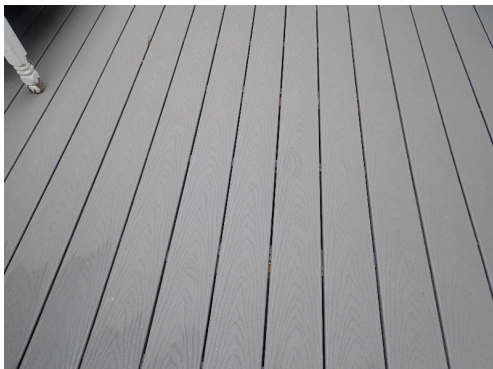
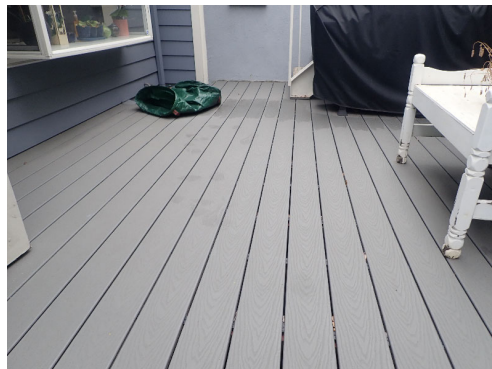
Building - Patio Deck; Maintenance & Repairs - 2029

This component is for the maintenance and repairs of the decks. This is not for full teardown & full replacement. Plan on repairs, resurfacing and partial replacement of boards due to normal deterioration and wear.

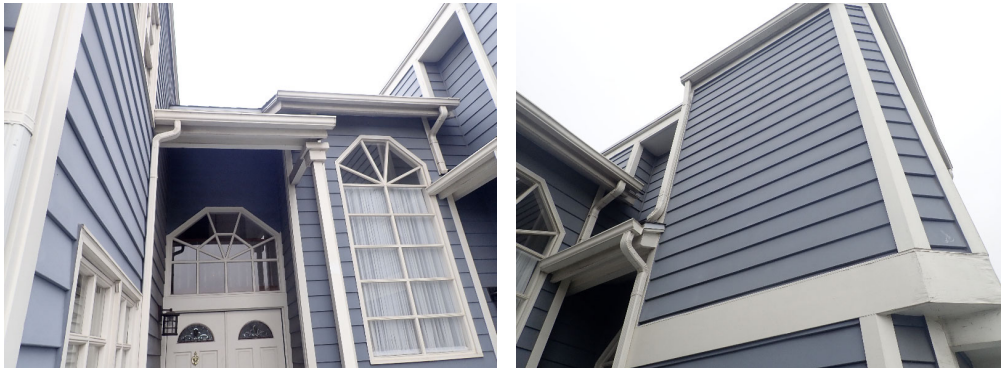
Building Exteriors - Siding & Trim; Repairs/Replacement - 2028

This component covers the periodic repairs and/or section replacement of siding & trim located throughout the building exteriors.

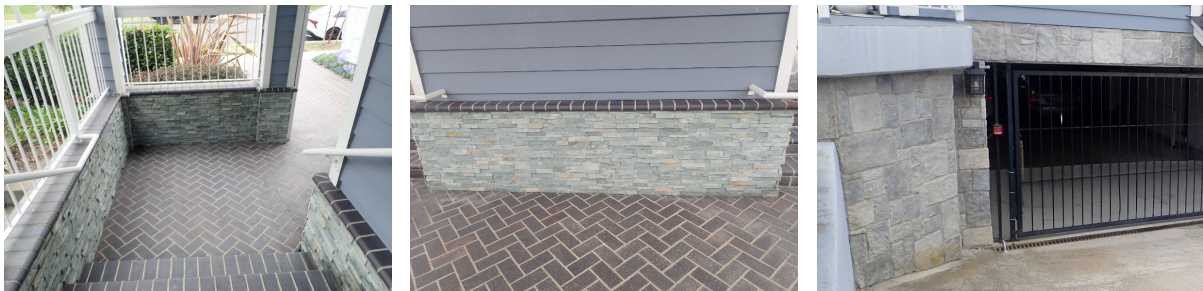
Fencing - Masonry Wall; Maintenance & Repairs - 2034

This component is for the periodic maintenance and repairs of the masonry wall located at the Alta Vista Dr. entryway, garage entry and garage exit. At the time of inspection, the wall was overall in good condition. Since this component will last the life of the development and exceeds the scope of this study, this item is for periodic and ongoing maintenance. Such maintenance may include pressure washing, efflorescence removal, pointing, and minor

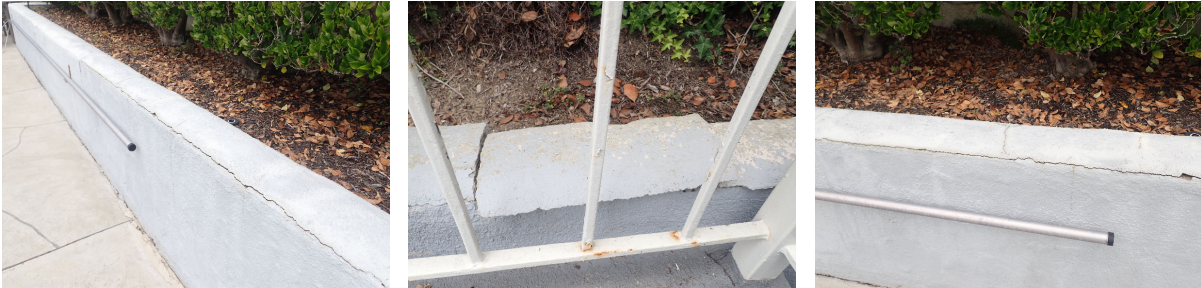
Fencing - Retaining Wall; Maintenance & Repairs - 2025

This component is for the periodic maintenance and repairs of the retaining wall. Since this component will last the life of the development and exceeds the scope of this study, this item is for periodic and ongoing maintenance. Such maintenance may include pressure washing, efflorescence removal, pointing, and minor masonry repair. At the time of inspection, the wall was overall in fair condition but had a significant cracking along the top of the wall including some chipping at a few locations. We recommend this component be consulted on and repaired as soon as possible to prevent further degradation of the walls. Painting is provided for in another component.

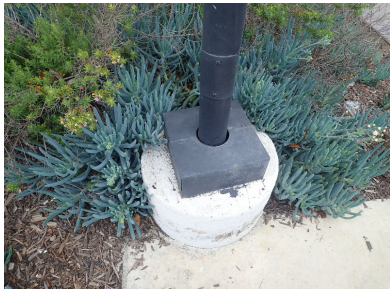
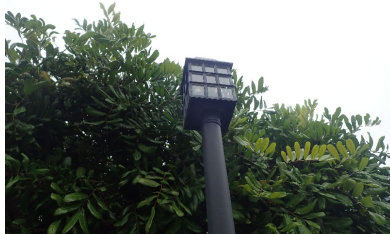
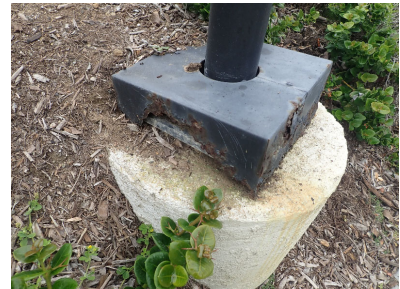
Lighting - Post Fixture; Replacement - 2040

This component is for the replacement of the post lights fixtures located on the pathways between the buildings and on Granda Drive. This component assumes that existing wiring and conduits will be reused. At the time of inspection, the condition of the lights was fair. The fixtures and poles look fair but the condition of the base of the post was varying with some rusted through at several points. Operation of the lights was not observed as the inspection took place during the day. Painting is provided for in another component.

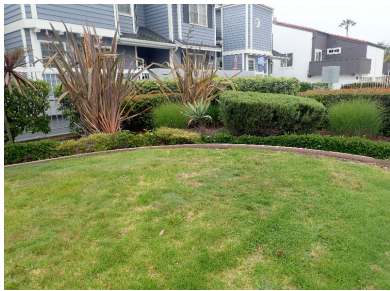
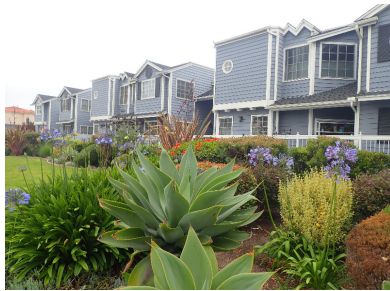
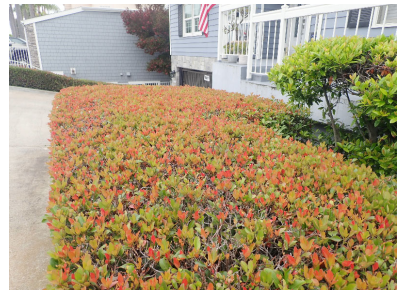
Landscape - Replenishment - 2029

This component is for the replacement and replenishment of the landscape ground cover. This landscape includes many different types of plants and trees. All of the different landscape items will have different life expectancies. This is an average estimate which may vary based on climate, drought conditions, damage from animals, etc. Pruning, trimming, and other maintenance is handled operationally.

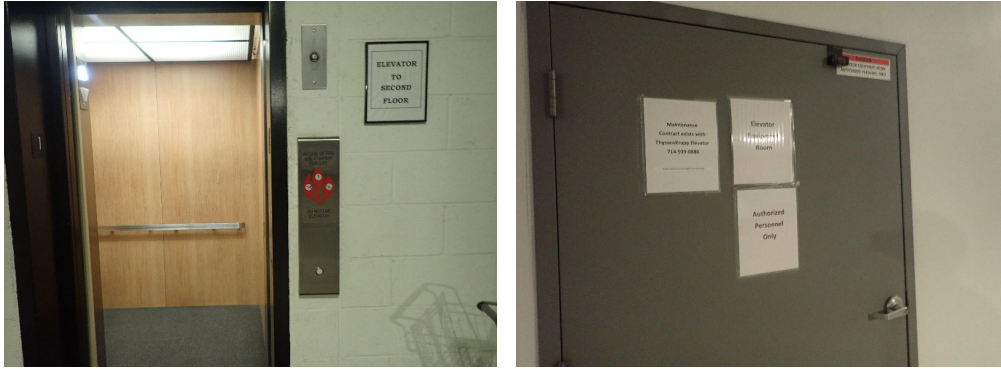
Equipment - Elevator; Overhaul/ Modernize continued...

This component is to modernize or overhaul the elevator system. As the elevator ages, the working components will begin to fail. Replacement parts may become unavailable, new technologies will emerge and become incompatible with old components, or the building and safety codes will change causing the necessary upgrades. This does not include building modifications and is only for the overhaul and replacement of the elevator components.

*Annual inspections are recommended. Maintenance is handled operationally.

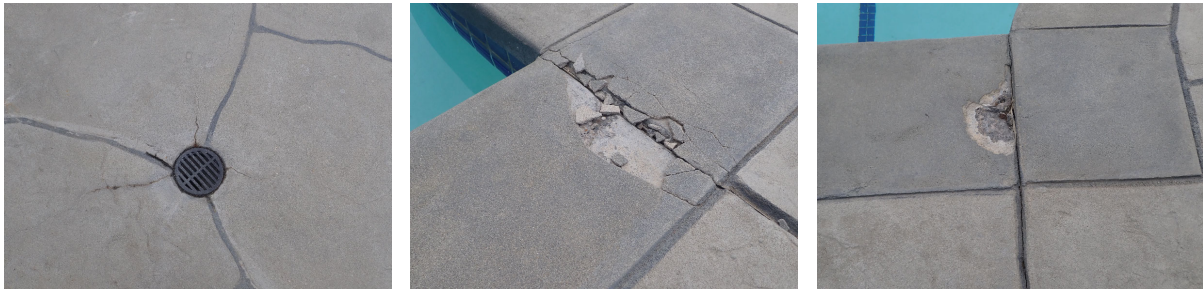
Paving - Deck; Maintenance & Repairs - 2025

This component covers the periodic repairs of the concrete pool deck. Annual inspections are necessary to ensure the correction of any elevation changes and trip hazards. Which will help reduce liability to the association. When cracks occur and are not repaired in a timely fashion, moisture can infiltrate and further degrade the materials. The concretes overall appearance at the time of inspection was in fair condition. Although this there were some noticeable cracks and chunks of missing and loose concrete that needs to be fixed before they become larger and deteriorate the entirety of the deck.

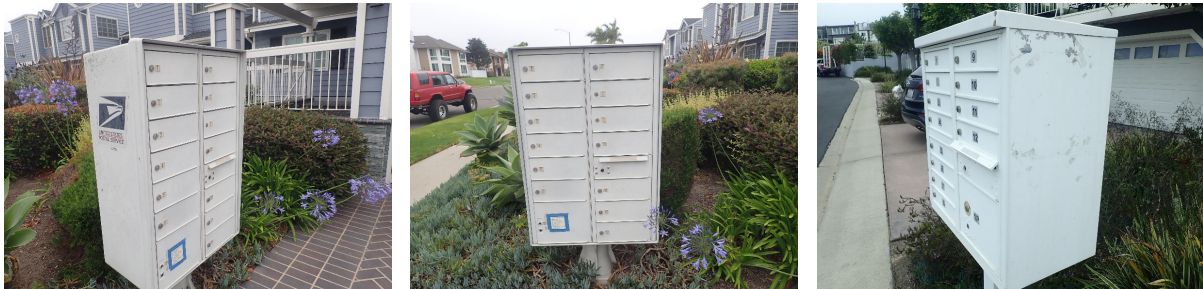
Mailboxes - Cluster Box; Replacement - 2039

This is to replace the cluster mailbox containing 12 boxes and 1 parcel locker & the cluster mailbox containing 13 boxes and 1 parcel locker. Locks and hinges should be lubricated seasonally, or as found necessary. At the time of inspection, the mailboxes appeared to be in fair condition, without major signs of surface rust, dents, excessive wear, warping, or vandalism.

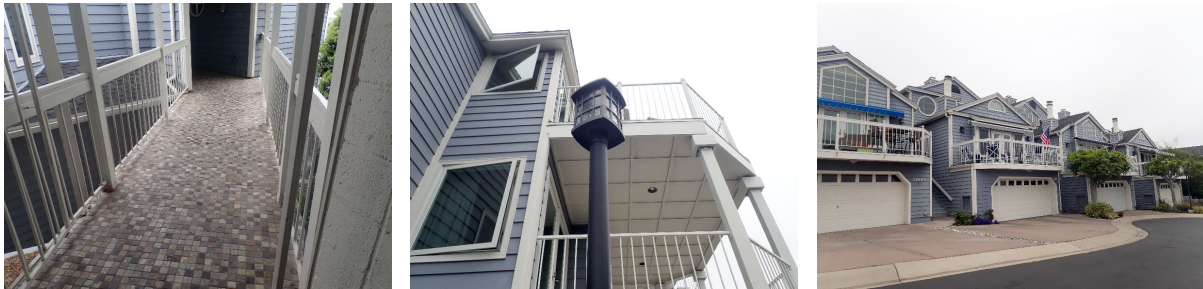
Contingency - Balcony Inspections; SB 326 - 2032

As required by Senate Bill No. 326 - Exterior Elevated Elements such as the (Balconies and/or Stairs) are subject to Inspection. More specifically, the first inspection is required to be done by end of year 2024. Then every (9) nine years thereafter.
